## FIXING EXHAUST MANIFOLD LEAKS

By Alex Janke

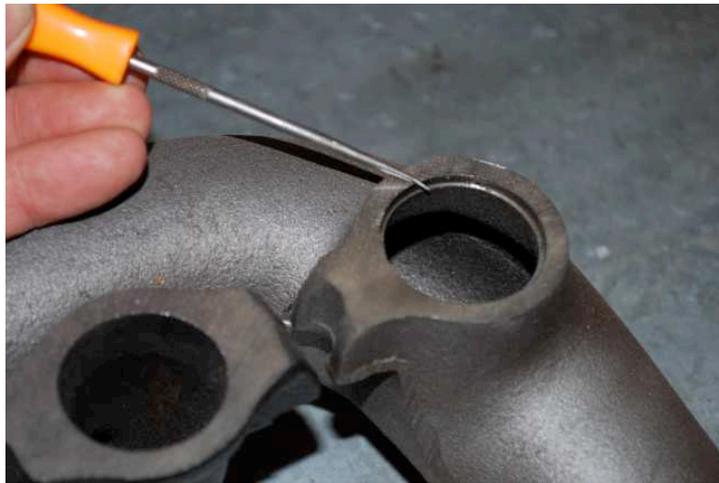
**Counter Bore in Exhaust Manifold**

At the rear exhaust ports temperatures can reach 900 to 1200 degrees F. At those temperatures the weight of the muffler can cause the rear port to sag as much as 1/2 inch, causing a misalignment between the port and the gasket, creating an exhaust leak.

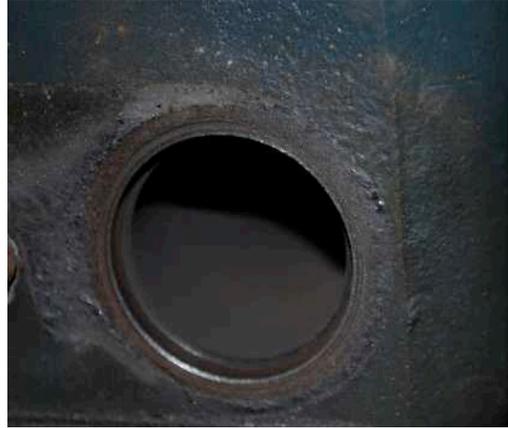
**Below is a new manifold that has been mated with intake manifold and machined flat, note the exhaust openings are in alignment intakes are slightly smaller than exhaust so they do not match but are centered correctly.**

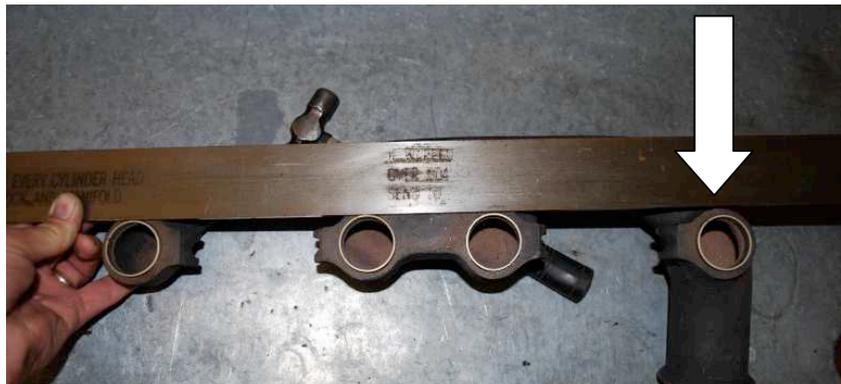
The standard exhaust manifold carries all the weight of the muffler and tail pipe. Over time this weight and the heat generated in the exhaust manifold causes the cast iron in the manifold to sag unless gland rings are installed.

**Used original manifold showing sag of about 1/2"**

Eventually the manifold leaks and it is too late to reuse it because of sag. New glands will not fit and the ports will not align. Good gaskets can obtain a seal if the ports do not line up, but over the course of time the gasket will leak around the weak point of the seal.

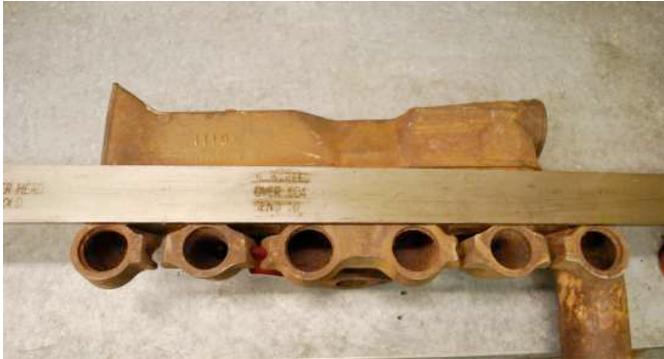
Exhaust manifolds with heaters generally did not experience excessive sag because of the additional material helped carry the weight.

**Well-used exhaust manifold heater that shows no sag**

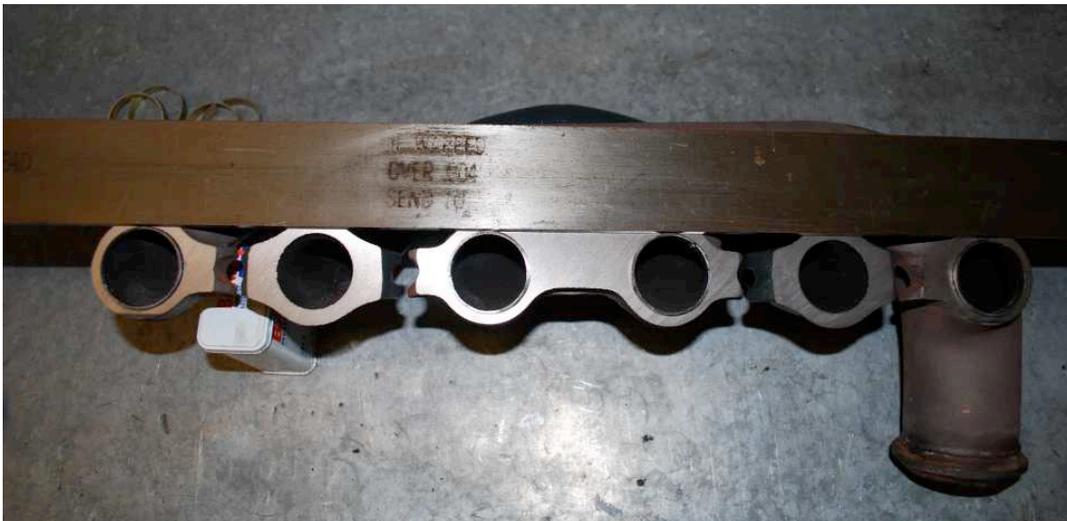
Using glands prevents both leaks and sags. Here is a photograph of an exhaust manifold that had been installed using glands for 7 years and driven over 50,000 miles yet has very minimal sag.

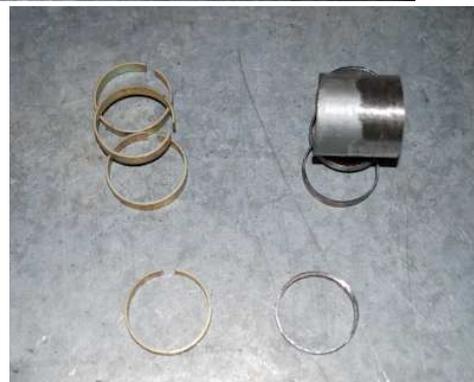
**Glands sold by suppliers on left and homemade glands made from conduit on the right**

Glands are sold by all the part suppliers and are of the split ring type. These can be pressed into the counter bore by hand. Glands can be fabricated using a piece of 1 1/4" EMT conduit. The EMT is just slightly too large and can be machined or sanded down to fit and cut with a hack saw or band saw.
