## FIXING EXHAUST MANIFOLD LEAKS

By Alex Janke

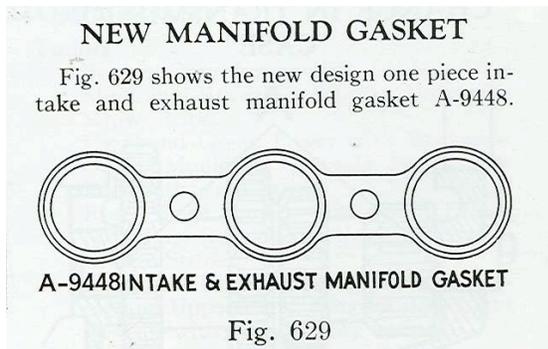
### **Service Bulletin January 1928**

In the January 1929 Service Bulletin, a new manifold gasket was introduced that would, “...eliminate the counterbore for the glands in both the manifolds and cylinder block...” This new design was to be installed without glands.

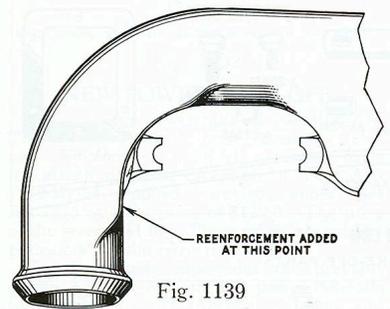
In March of 1931, a strengthened exhaust manifold was introduced to help prevent some of the “sagging”. This new design kept the counter bore and the additional reinforcement acted much like the extra material on a heater manifold.

The best results are obtained with both a new intake and exhaust manifold from the parts suppliers. They should be mated and port surfaces machined flat. The amount of machining is minimal, but essential. With glands, a good gasket, and careful torque application this arrangement should provide an engine free from manifold leaks for years of touring.
